REVISED ANADROMOUS STREAM CATALOG OF SOUTHEASTERN ALASKA

District 106

Northeast Coast of Prince of Wales Island

Subdistricts 106-30 and 106-10

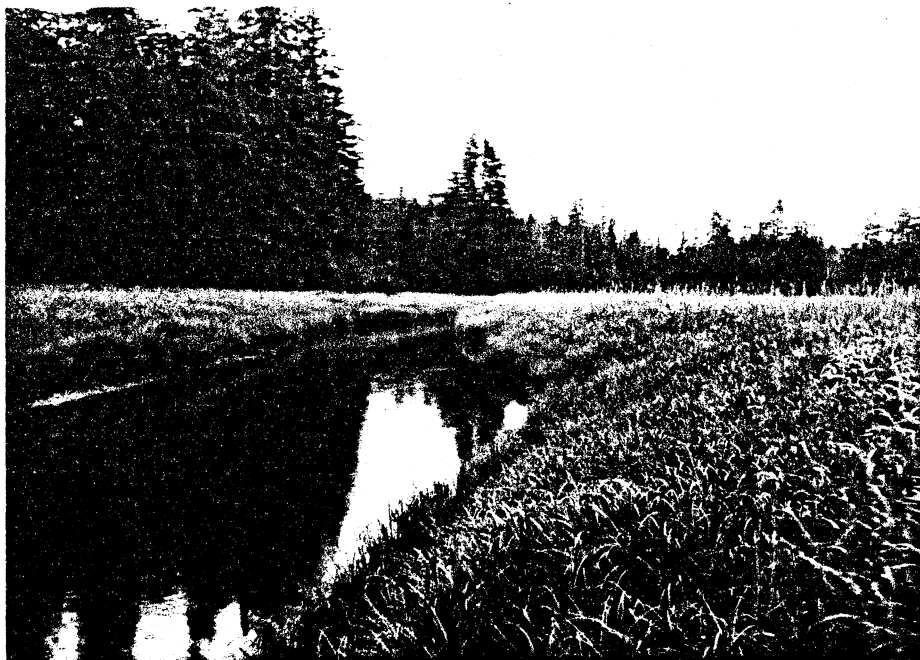
Recon Creek
106-30-090

1. Shallow intertidal rearing slough containing
SS/DV fry.

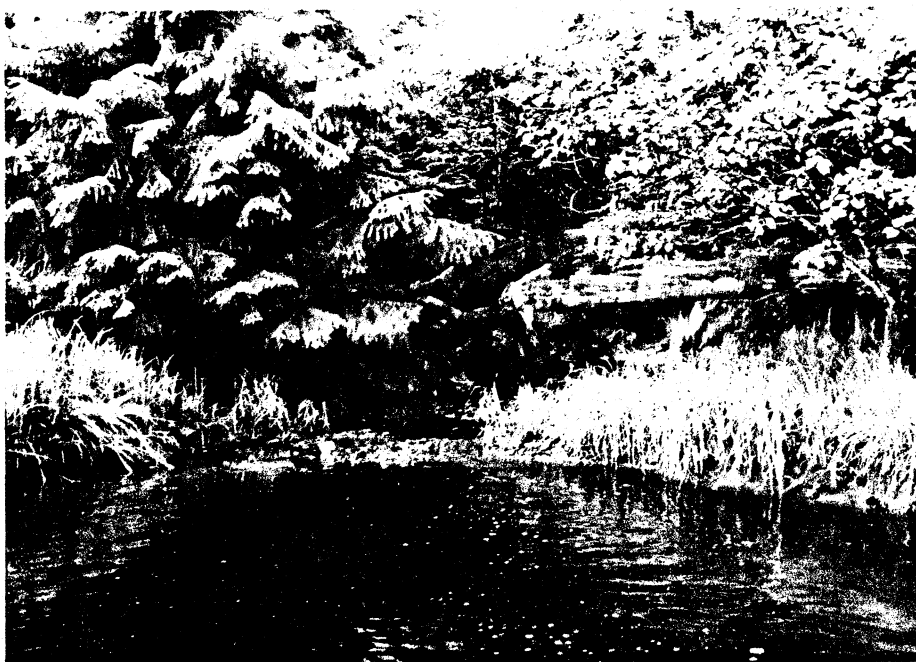
2. Mouth of stream where the ITZ rearing slough
ends and stream flow over bedrock begins.

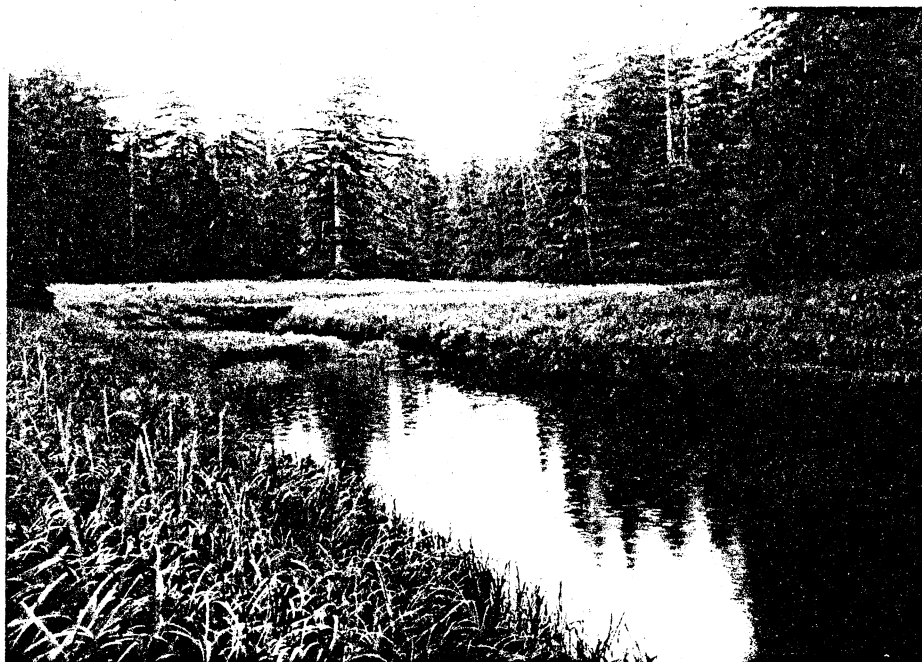
1. Stream mouth lies at the head of an extensive intertidal slough.

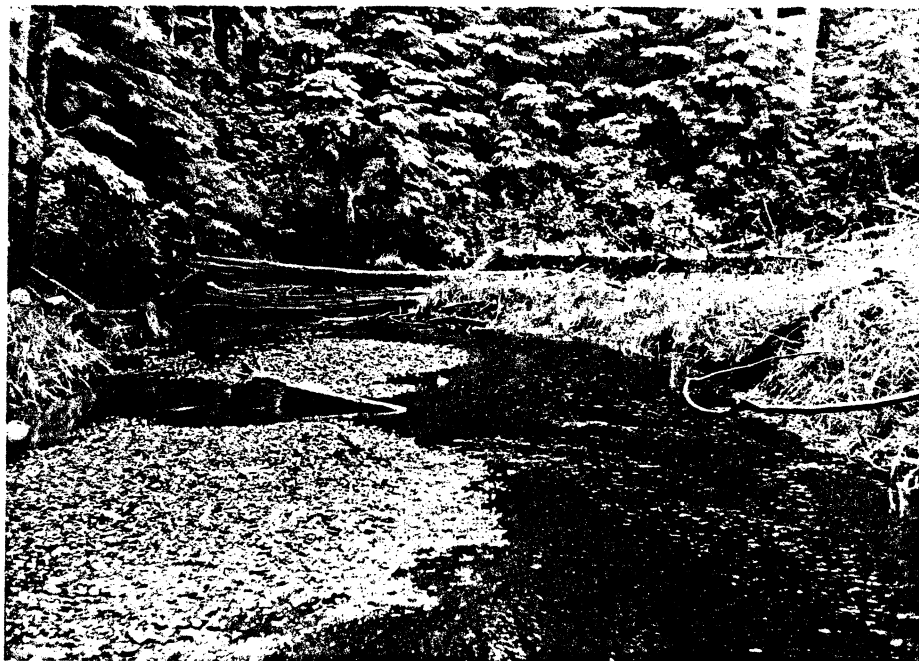
2. The upper ITZ is characterized by gravel riffles and a vegetative transition of marsh grass to timber.

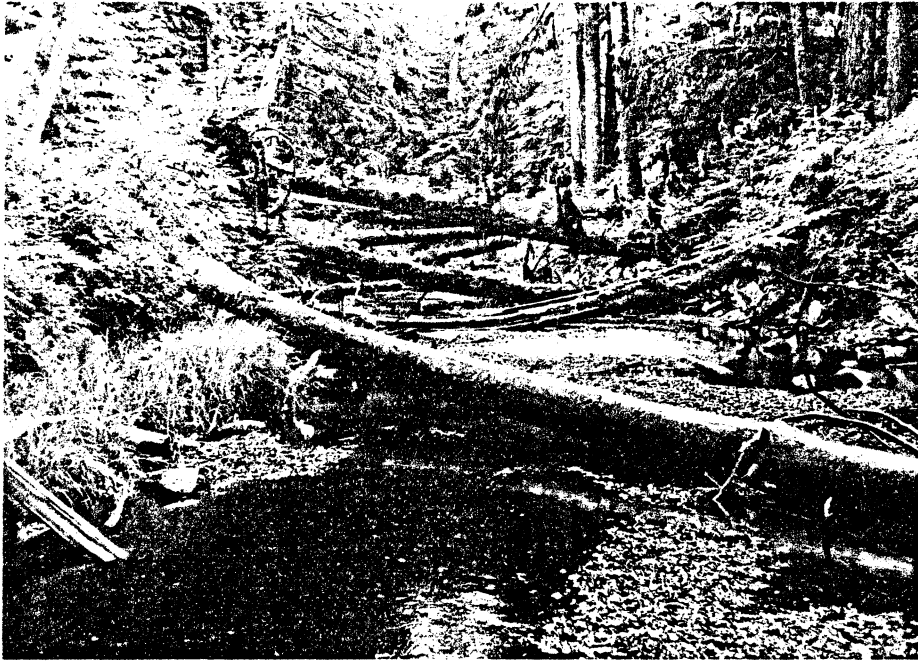
106-30-89

3. Section 1: Gravel riffles, SS pools, and copious blowdown provide excellent spawning and rearing habitat.

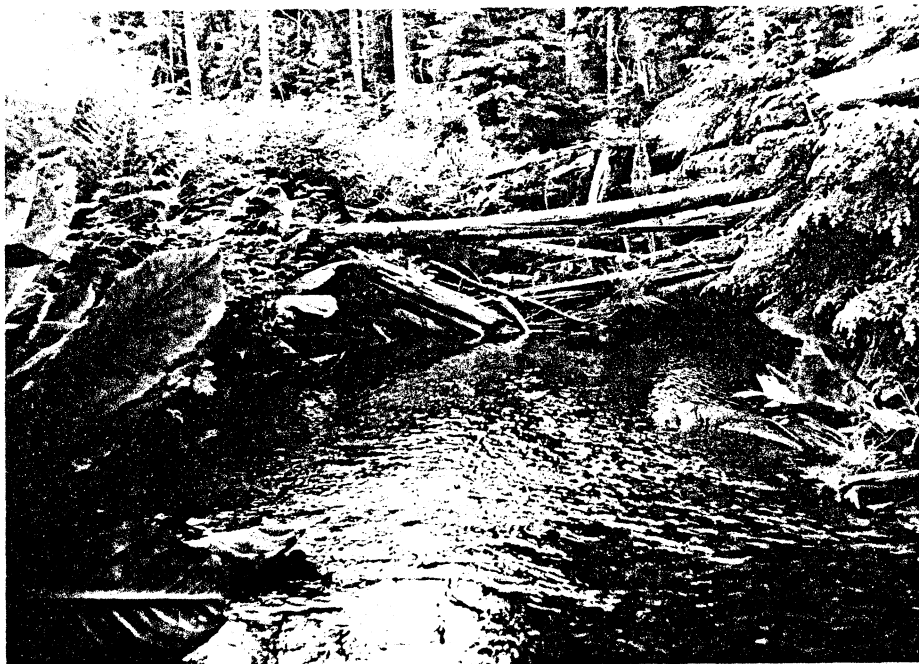
5. Downstream view of copious instream logging debris and the right bank unit boundary.

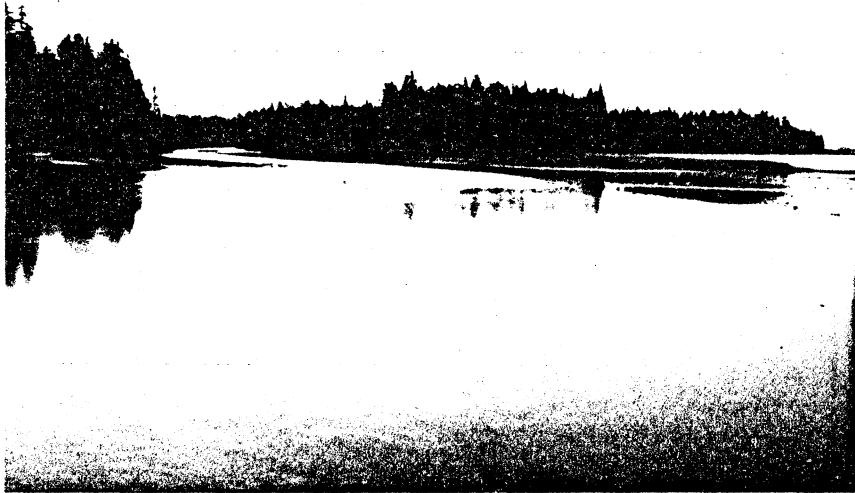
First West Lava Creek
106-30-088

1. Lower ITZ of 106-30-088.

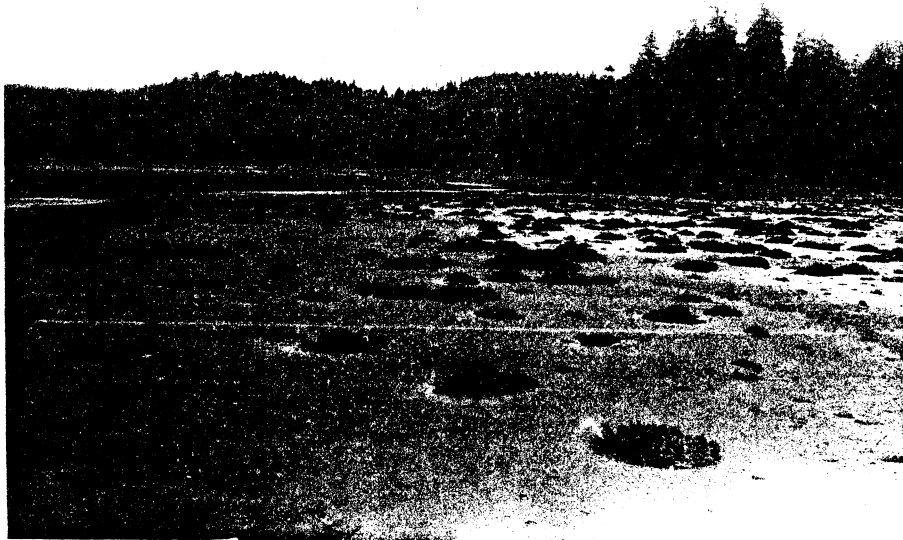
2. Downstream view of lower ITZ extending toward Kashevarof Pass.

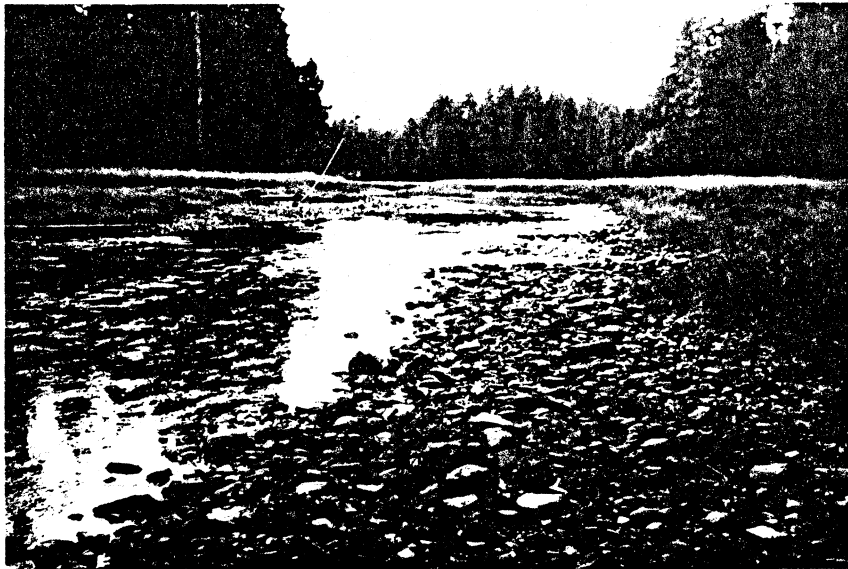
First West Lava Creek
106-30-088

3. Middle ITZ with grass meadow to right.

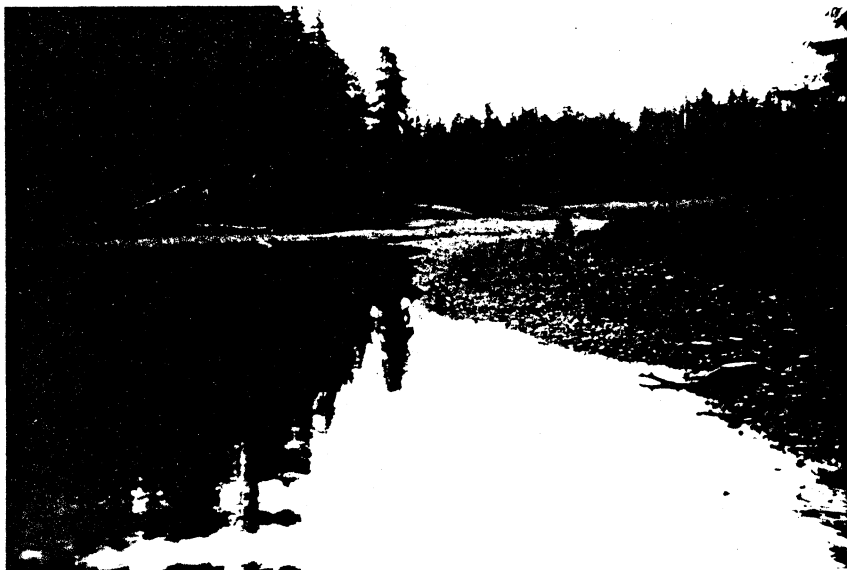
4. Downstream view of ITZ from mouth of stream.

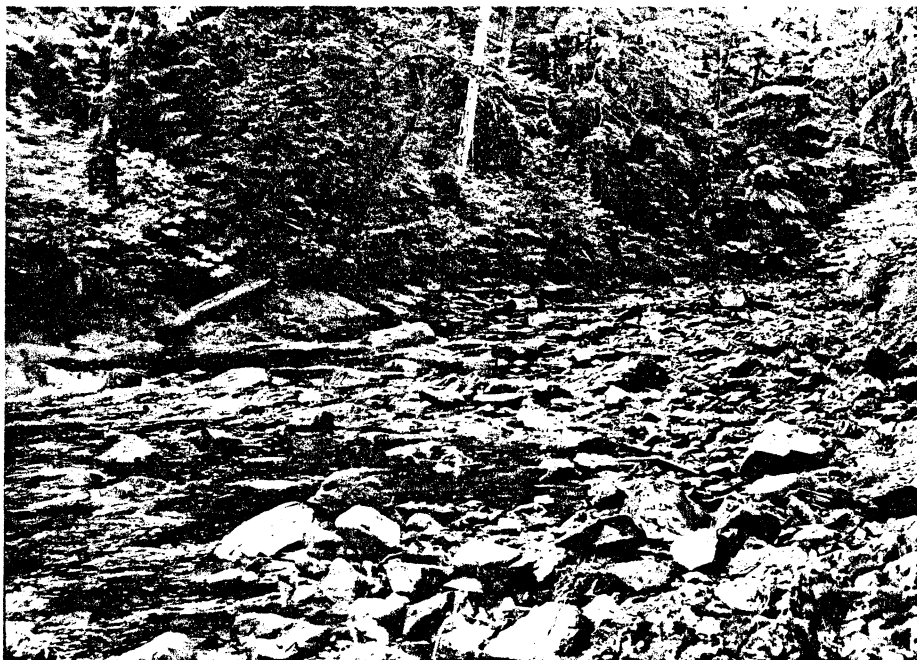
First West Lava Creek
106-30-088

5. An abrupt substrate transition demarcates the ITZ/stream ecotone; i.e., mouth of stream.

The transition in habitat from ITZ to stream is quite abrupt. Heavy fines and small cobble with moderate ASA gives way to a bedrock/boulder V-notch with little fish habitat. A dense algal growth occurs on the bedrock. Small amounts of coho and trout fry were observed.

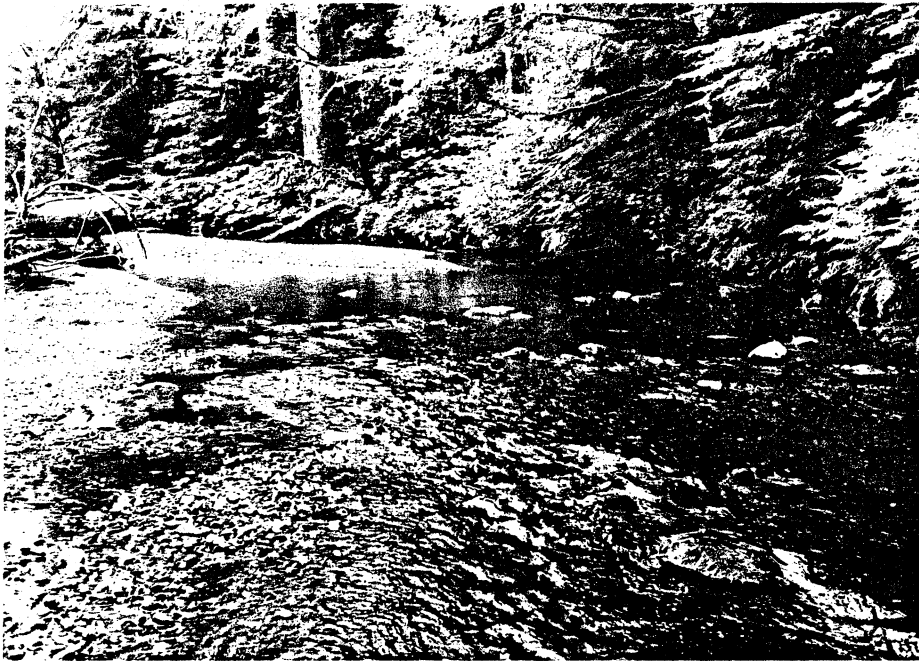
First West Lava Creek
106-30-088

7. Above notch, channel broadens and spawning/rearing habitat becomes common.

The stream emerges from the V-notch and broadens out into cobble/gravel riffles with good spawning and rearing habitat. Debris jams and fines deposition scattered through the upper portion of the reach. Increased concentrations of coho fry were observed. The reach ends with the confluence of Tributary "B" in the right bank.

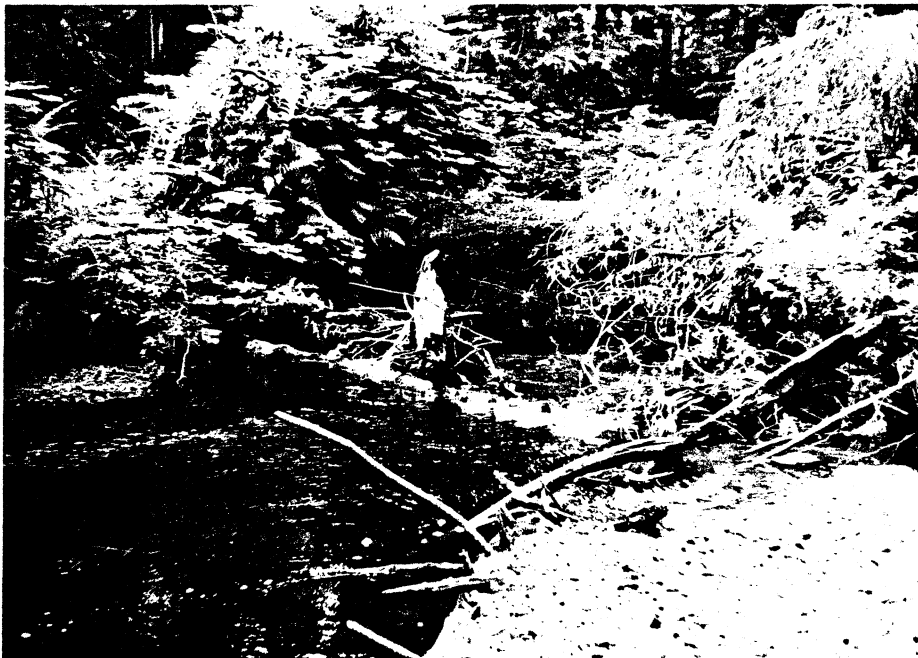
8. Section 12: Braided channels, blowdown, bank undercutting, and accelerated bar formation characterize this extremely disturbed section.

Throughout the reach there is a considerable amount of instream fines and debris. Large debris jams, formed principally with stump root wads and buffer strip blowdown, often cause braiding and channel migration. This in turn results in aggravated bank instability and more blowdown. The width of the post logging buffer strip varies from 0 meters to 30 meters, usually involving 0 - 3 trees from the bank which is hardly adequate. Water temperature increased to 14°C and a heavy algal deposition occurs on the substrate in an area immediately above the bridge where there is zero canopy coverage. Heavy concentrations of coho fry were observed in this reach.

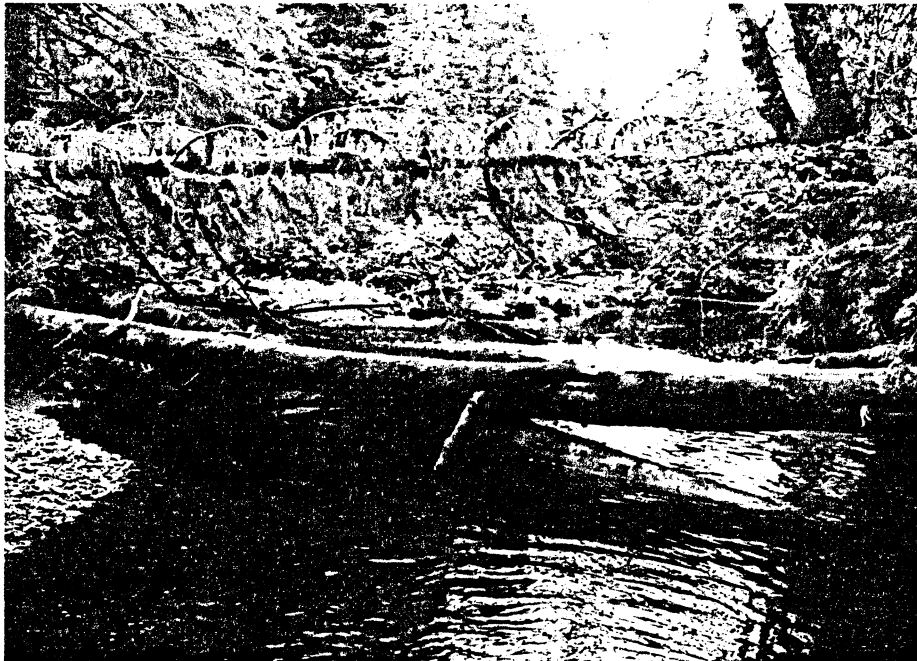
First West Lava Creek
106-30-088

9. Section 13: The confluence of Survey Area "B" and the Main Stem.

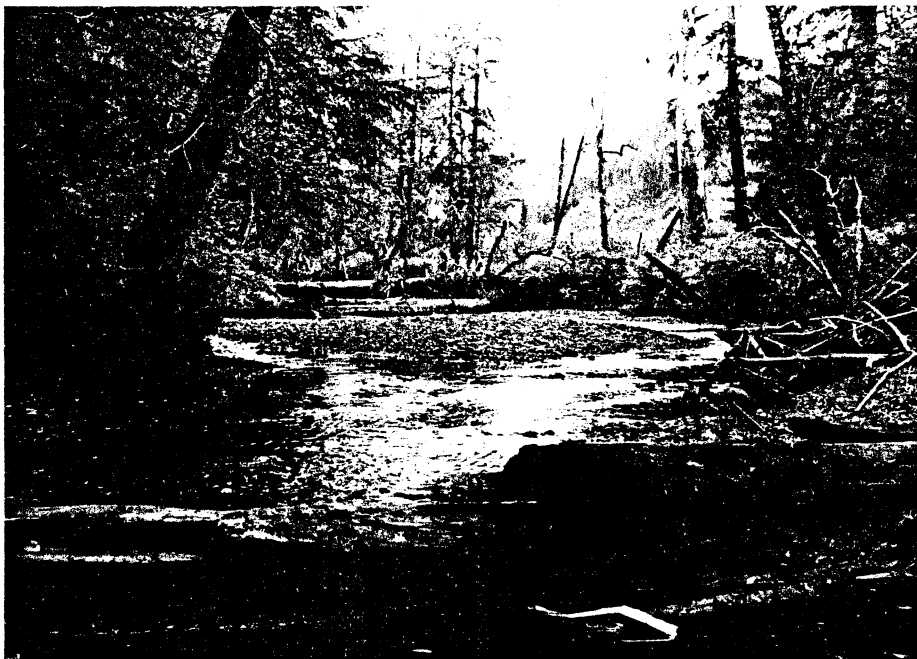
10. Section 14: Riffle over small cobble and gravel. Good ASA and fair rearing habitat.

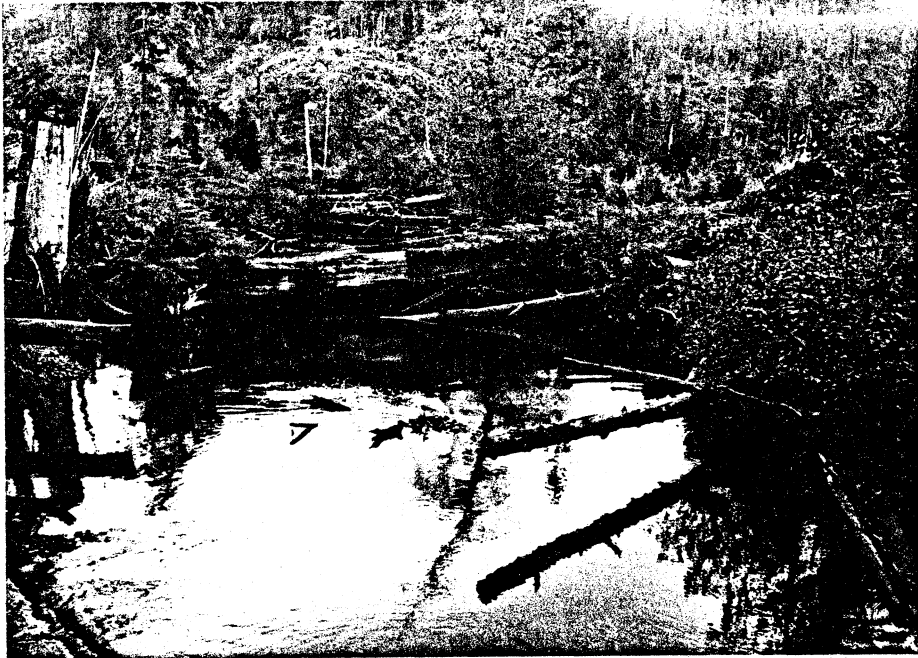
First West Lava Creek
106-30-088

11. Left Fork, Section 15: Upstream view taken from mainline logging road bridge crossing shows a clearcut unit to both banks and copious debris. 20+ adult PS were observed milling in foreground.

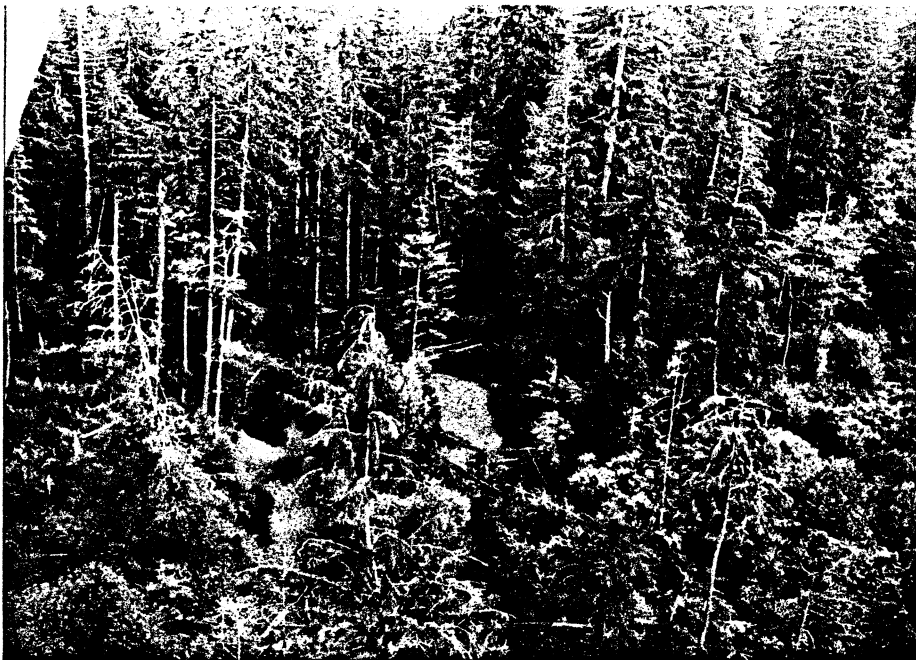
12. Stream leaves unit and enters mature forest cover.

The main stem leaves the unit and enters old forest growth. The unit is approximately 100 m distant from the right bank and the remnant buffer strip appears stable. Substrate size, gradient, velocity, and bank slope gradually increase through the course of the reach. Conversely, ASA and fish observations decrease. There is a midstream island forming two channels for 100 meters, each with isolated debris jams. Moderate amounts of coho fry were observed.

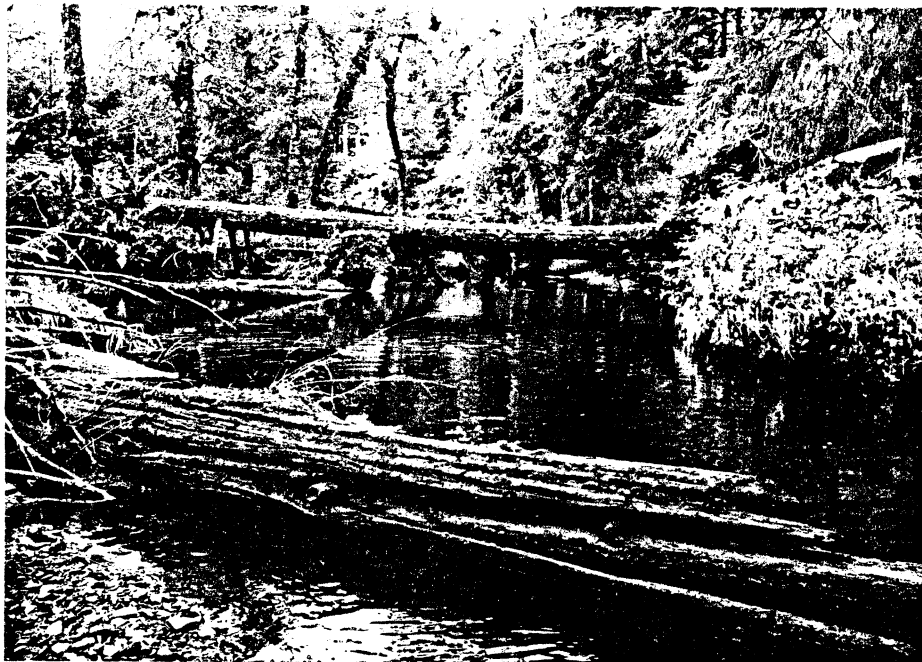
14. Survey Area "B", Section 1: Deep, slow water provides good rearing habitat just above the forks.

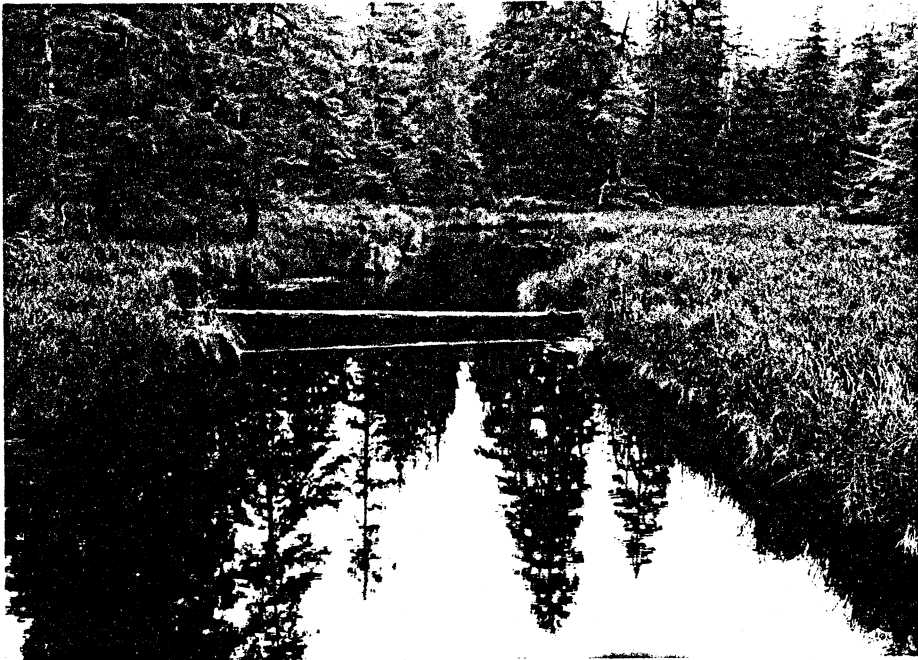
First West Lava Creek
106-30-088

15. Right Fork: Beaver impounded slough-like channel provides excellent rearing habitat; however, no ASA was observed. Dark water hindered observations.

This fork is heavily beaver dammed for its surveyed length of 2,145 meters with approximately 750 meters of flowing stream between beaver dams. Primarily rearing habitat, heavy concentrations of coho fry were observed and trapped in this fork. A logging road with spurs is located 400 m from the stream with new units being cut in the watershed. The survey was terminated at a monolithic beaver dam (2.5m x 40m) at Section 14: 25m.

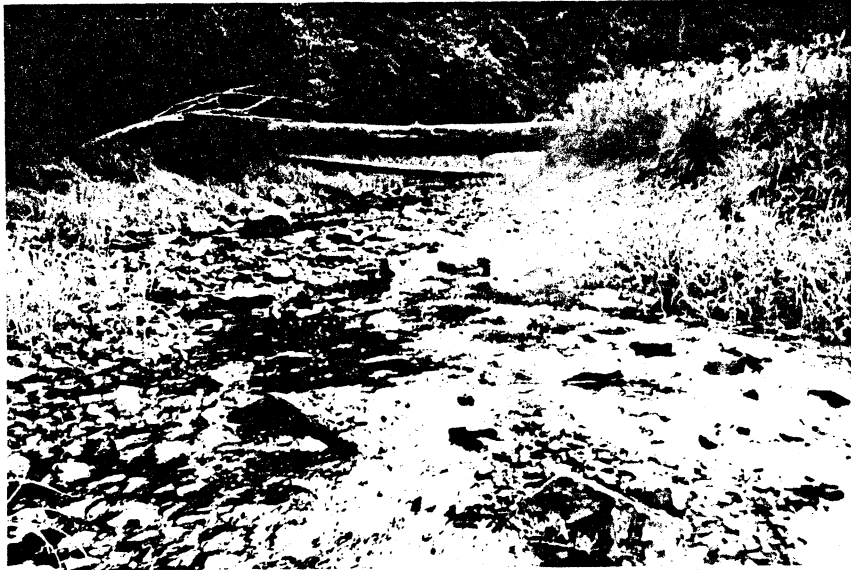
West Lava IT Creek

1. ITZ in grass meadow from confluence with 106-30-088.

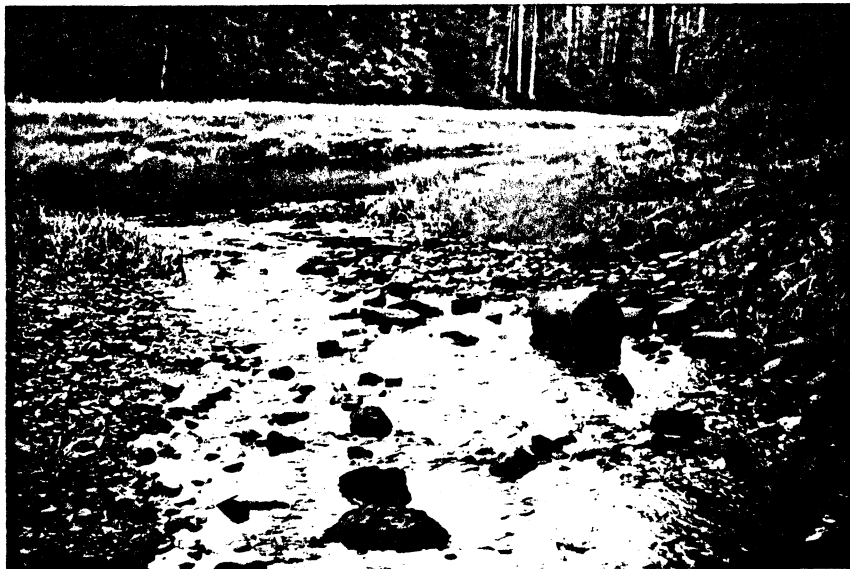
2. Downstream view of ITZ and confluence with 106-30-088.

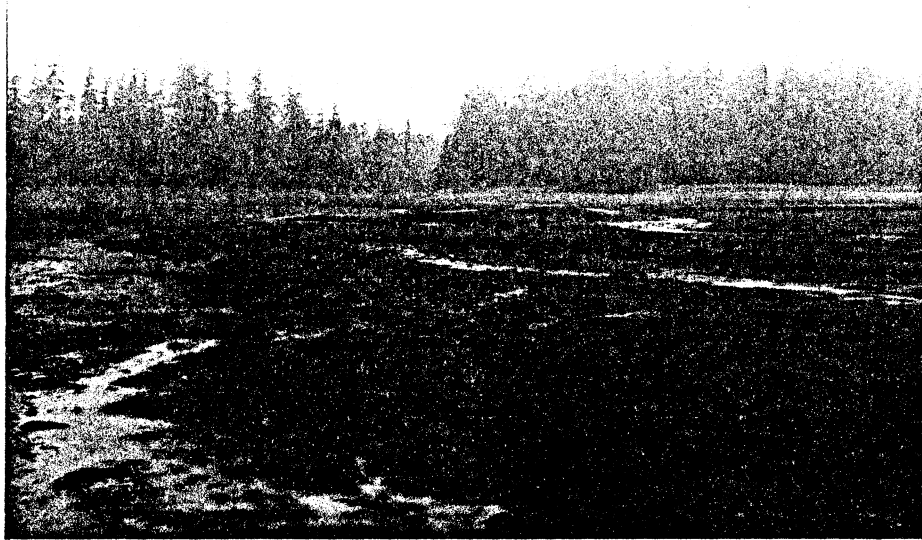
Lava Creek
106-30-087

1. Lower ITZ with extensive tide flat.

The lower ITZ is a large mud flat with a moderate amount of clams, and a low tide schooling area. The middle portion of the ITZ runs through a grass meadow in which a small stream enters from the left bank (see Lava Intertidal Creek). The upper ITZ has a boulder/large cobble substrate with rearing pools where coho and DV trout fry were observed.

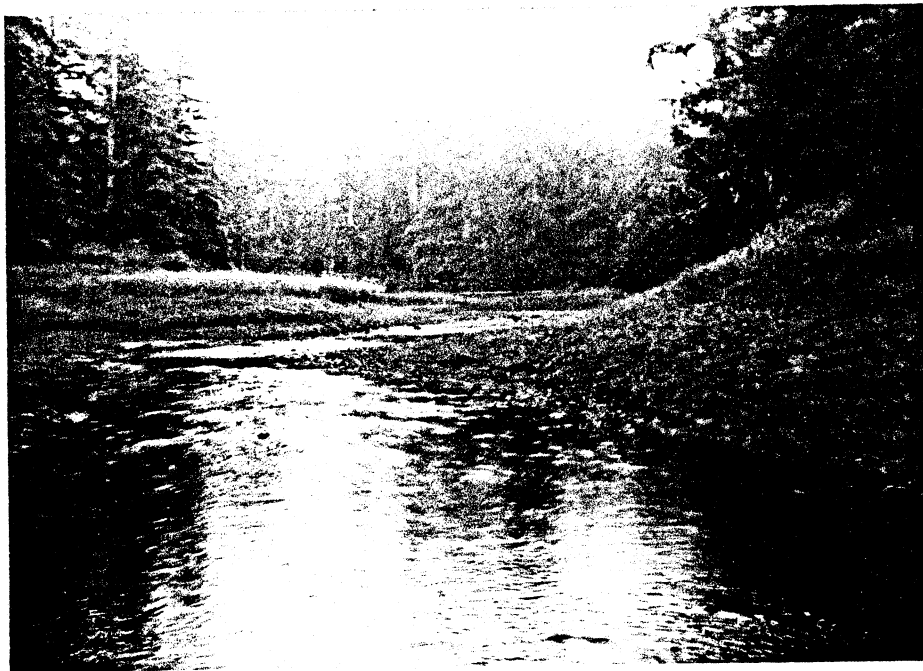
2. Upper ITZ with grass meadow as viewed from schooling area.

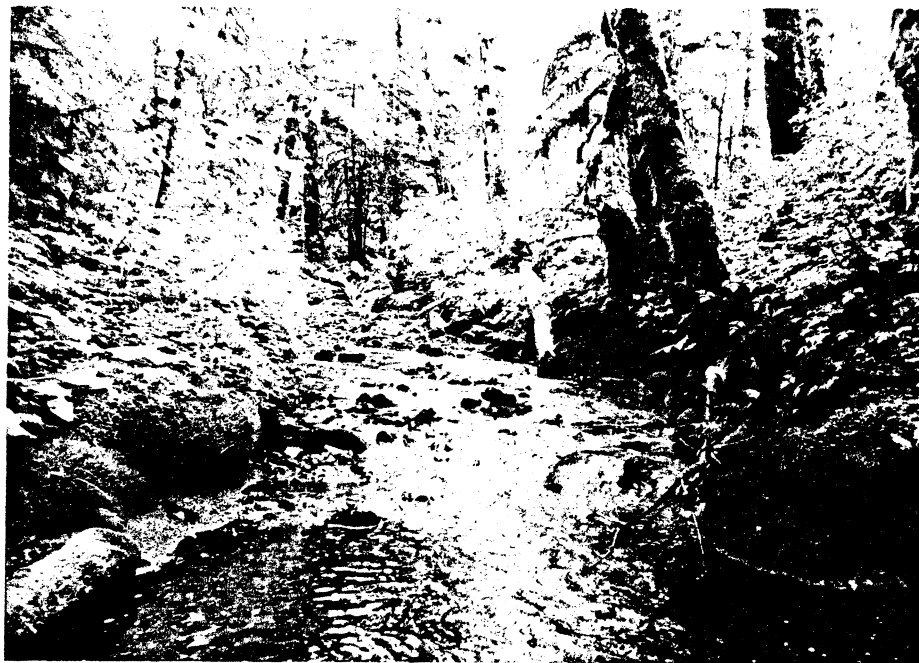
4. Representative habitat, Section 2: 0m;
Well-channelized high velocity flow over
bedrock/boulder/large cobble.

This is a low productivity stream with only DV trout fry observed in light concentrations. Coho fry were only observed in the ITZ. The substrate is predominantly bedrock, boulder and large cobble often with heavy moss growth. ASA is only found in small patches; rearing habitat is minimal. An active logging road crosses the stream at Section 2: 75m. A recent unit is located above and left of

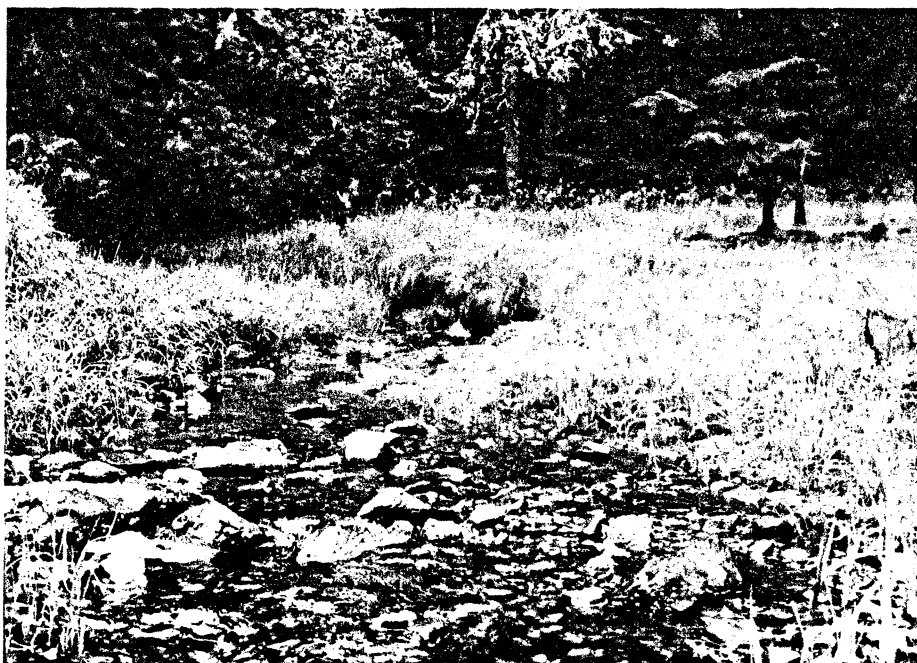
Lava Intertidal Creek

1. Mouth of stream with rearing ponds in meadows.
Shares left side IT meadow with 106-30-087.

This small rearing stream enters the grass meadow intertidal area of Lava Creek (106-30-087), left side. This stream has rearing pools in the first 25 meters where coho fry and DV trout fry were observed. After 25 meters, the stream enters forest cover and gains the characteristics of a muskeg drainage: low gradient, low velocity, light tan water, forbs in stream, and so on.

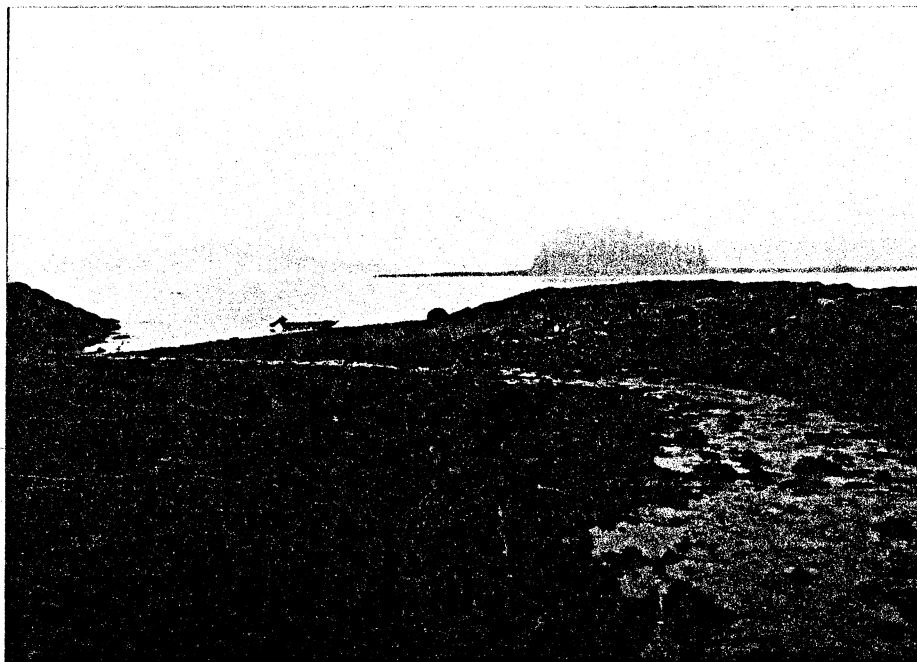
Fire Island 1

1. View down boulder strewn ITZ across Kashevarof Passage to Fire Island.

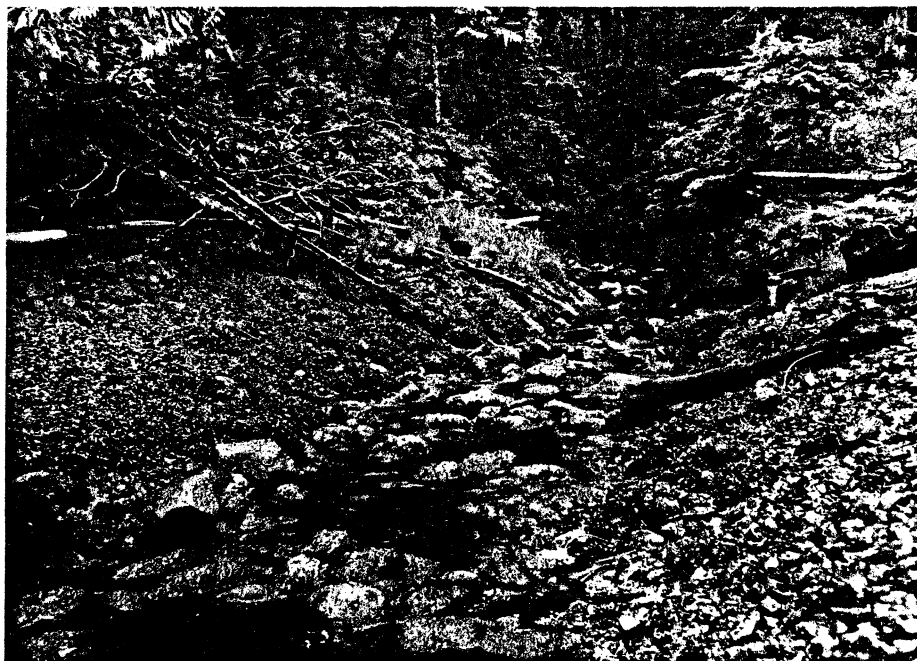
2. Boulder strewn upper ITZ ends at the base of a 4.0 meter high bedrock falls. No fish or habitat were observed.

This small, steep stream climbs a bedrock V-notch providing no fisheries habitat and enters the ITZ by pummeling over a 4.0 meter high vertical bedrock face. No fish were observed and no rehabilitation or enhancement recommended.

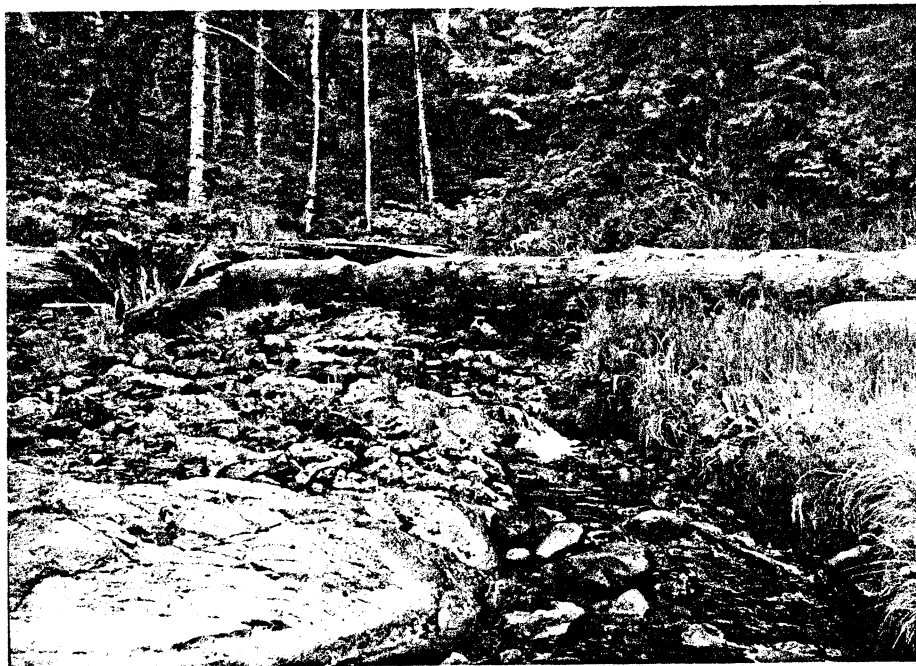
Fire Island #2

1. A clearcut unit borders this small, coarse channel just above the ITZ. Several juvenile DV and marginal habitat was noted.

Several juvenile DV were observed rearing in "fines" filled pools within 50 m of the ITZ. Adjacent to the blowdown zone, approximately 100 m above the ITZ, the channel climbs bedrock cascades which effectively block migration during periods of low flow. No fish or habitat were observed above this "barrier" and no rehabilitation or enhancement is recommended.

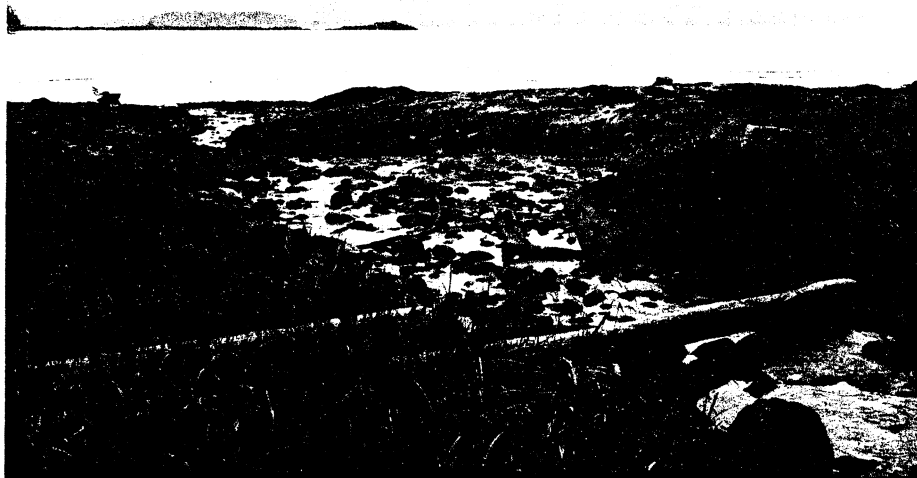
2. View down boulder strewn lower ITZ, across Kashevarof Passage to Scrubby Island.

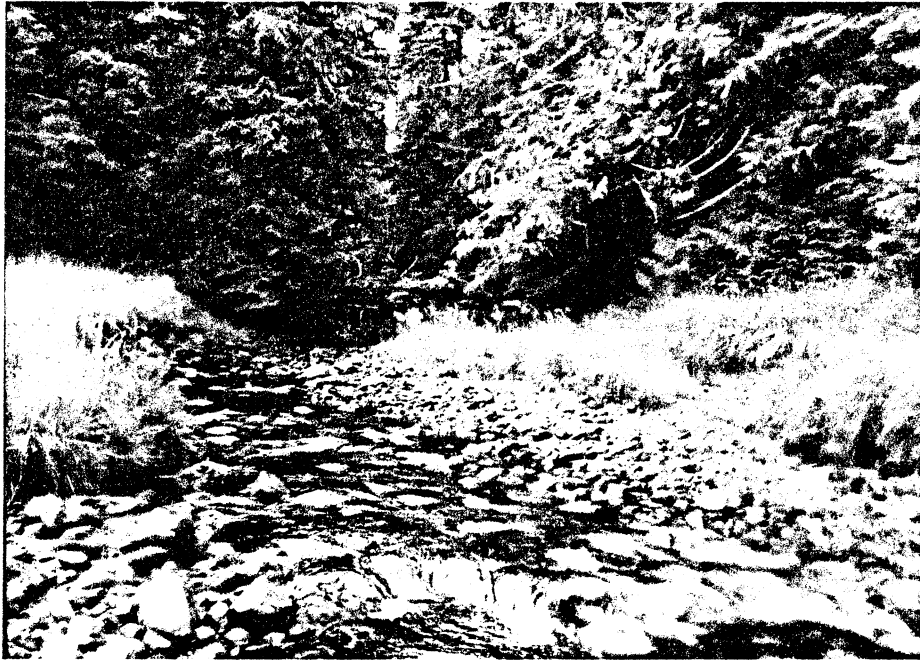
West Exchange Cove #1

1. Upper ITZ and stream mouth with flow over boulder/cobble.

This is a steep, fast mountainside stream with very little potential spawning and rearing area. Possibly, this stream could be used as a rearing area for coho fry in the first 100 meters, but none were observed at the time of the survey. The prevailing substrate is boulder/cobble. A road crossing via a culvert occurs at Section 1: 100 meters, which at high discharge levels, causes some downstream bank instability. Survey was terminated as stream heads up slope at rapidly increasing gradient.

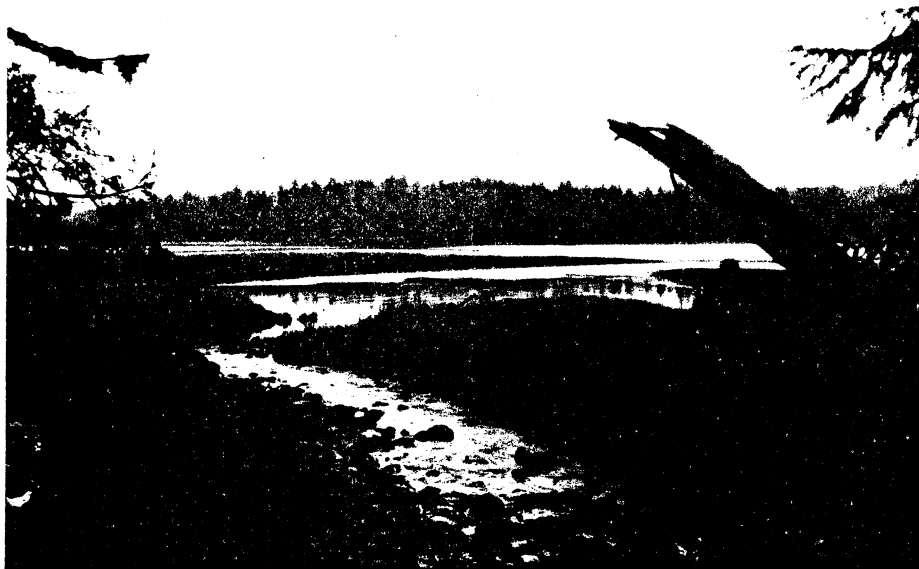
2. Downstream view of ITZ at high tide looking toward Exchange Cove.

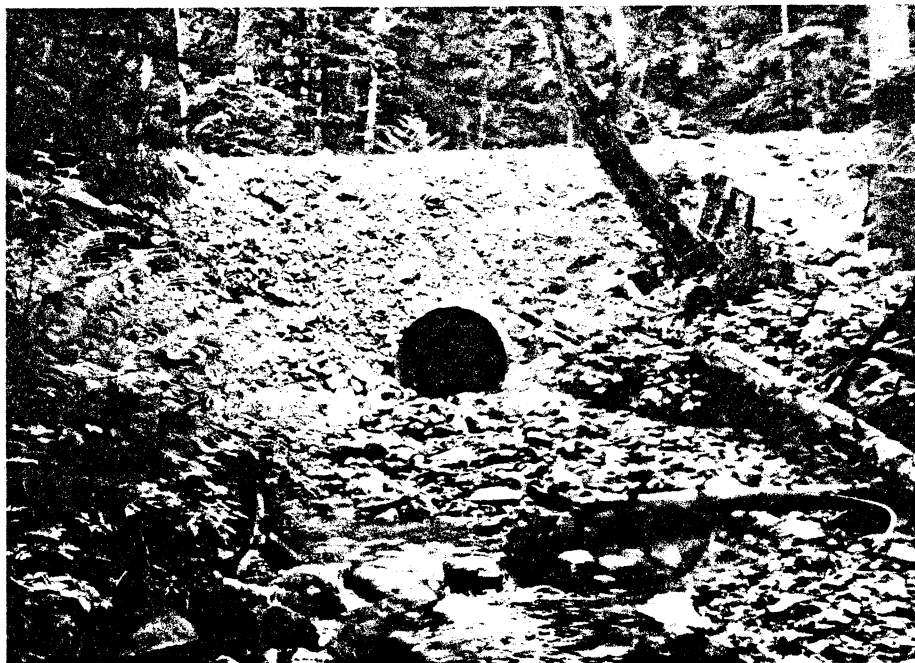
West Exchange Cove #1

3. Road crossing via 5' culvert, Section 1: 100m.

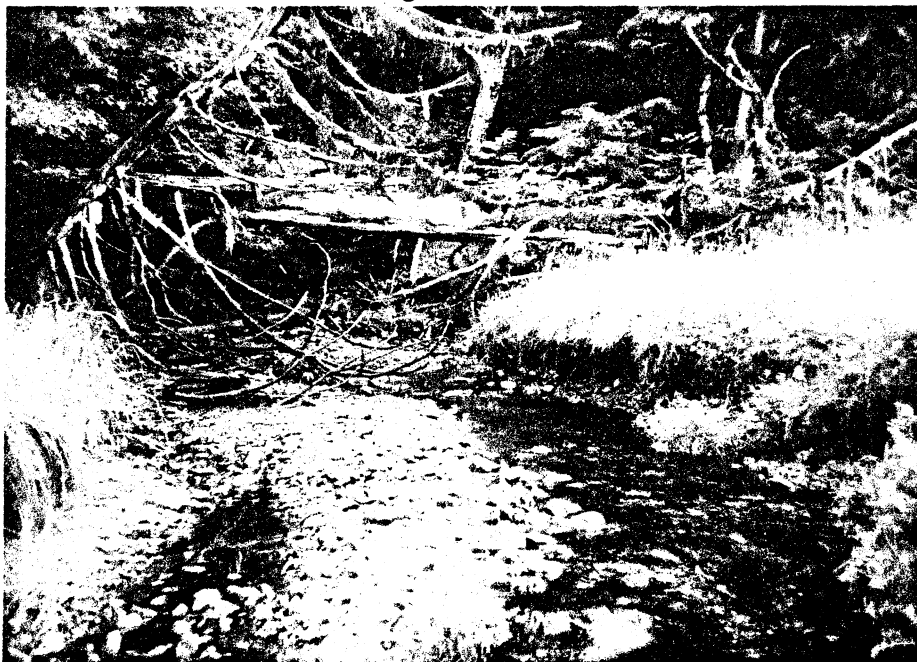
Exchange Cove West #2

1. Upper intertidal zone; copious debris and dense overhanging shrubs typify reconnoitered area.

This small stream crosses a logging road via a log culvert approximately 200 m above the ITZ. Orange and white forest service flagging was observed on the banks along the road, indicating resident fish habitat. Downstream reconnaissance revealed no identifiable spawning habitat and marginal rearing habitat. Three juvenile DV were observed. Channel characteristics include a 1.5-3.0 meter wide boulder/large cobble bed, primarily fast flow, copious debris and dense overhanging shrubs. Upon exiting treeline an extensive ITZ of "fines" meanders through a salt marsh providing 10 m² of spawning area and limited rearing habitat. Approximately 20 SS fry were observed rearing in several pools adjacent to the lone deposit of intertidal spawning gravel. No rehabilitation or enhancement recommended.

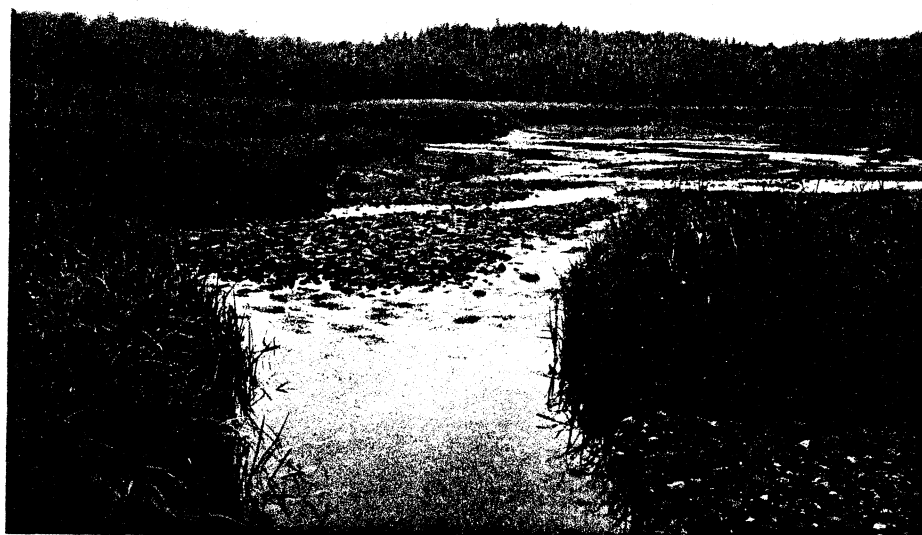
2. Sinuous intertidal slough contained one pocket of ASA and marginal rearing habitat.

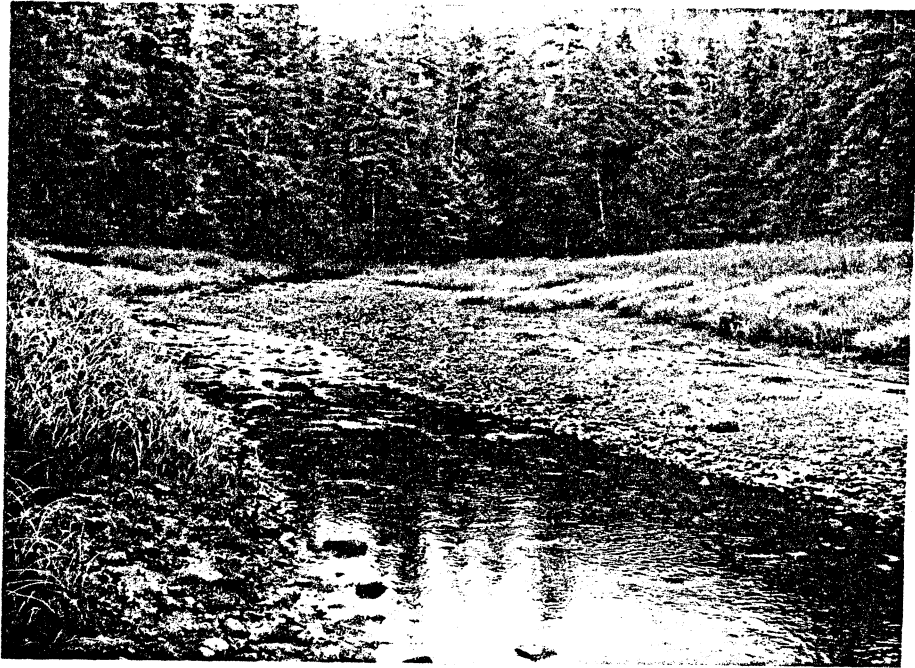
West Exchange Cove #3

1. Looking upstream toward the creek mouth. The ITZ provides excellent ASA.

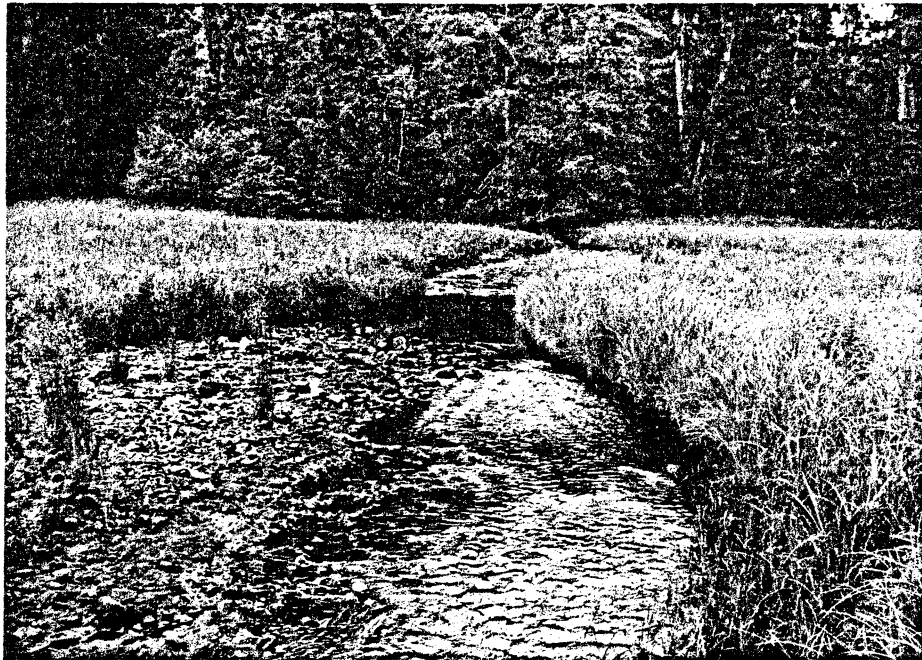
West Exchange Cove #4

1. The ITZ provides good ASA.

This stream shares the ITZ with West Exchange Cove #5 and subsequently with Exchange Creek. Intertidal ASA is good before it merges with the Exchange Cove #5 ITZ. Substrate consists largely of mixed cobble. The stream is susceptible to rapid flow fluctuations as evidenced by scoured banks. Coho fry were observed into Section 2.
